# Quantifying erosion in the Normanby catchment using repeat LiDAR and historical air photos

Graeme Curwen  
Australian Rivers Institute

Sediment Sinks Sources & Drivers  
in the Normanby Basin

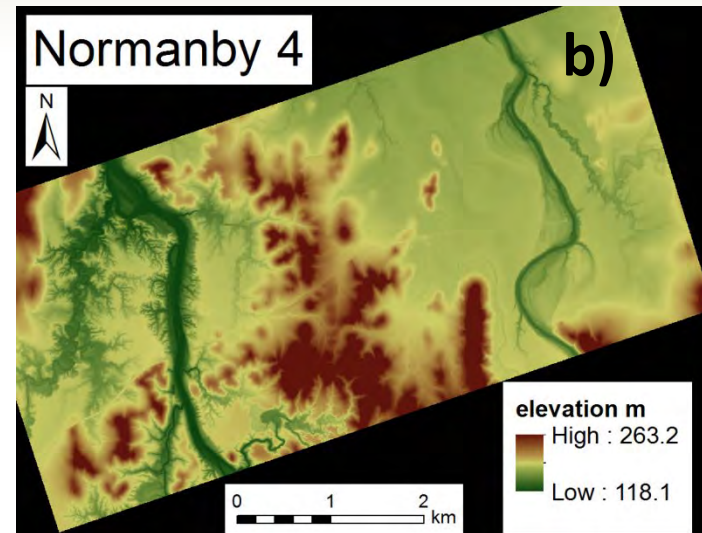
# Different remote sensing imagery available

- a) **Orthophoto** (georeferenced photo): 2D picture
- b) **Digital elevation model (DEM)**: 3D model of bare land surface, generated from LiDAR
- c) **Hill shade rendering of DEM**: highlights landscape features

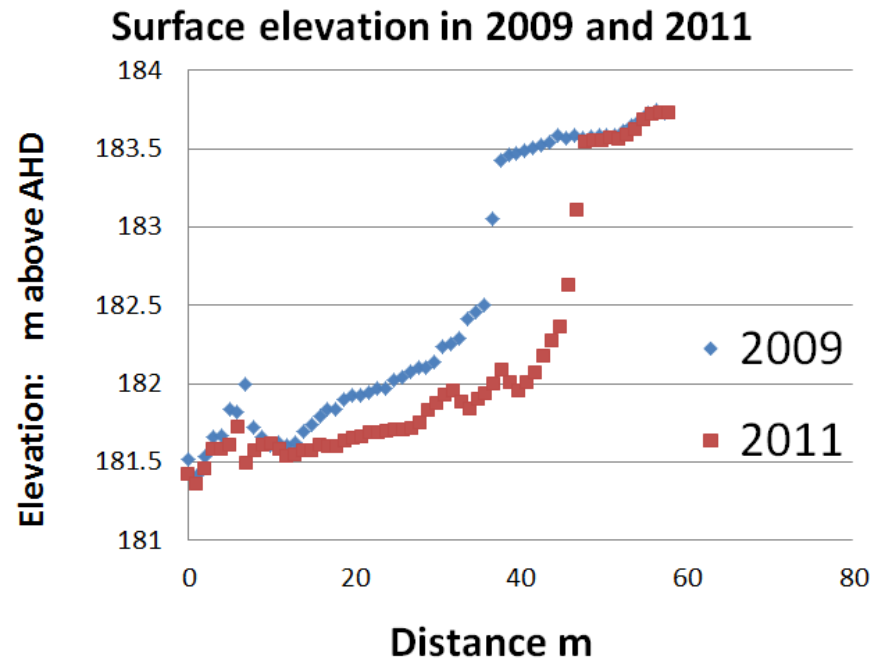
# Quantifying changes in area and volume from digital elevation model (DEM)

- Compare gullies between 2009 and 2011:
1. Extract height along transect line through DEM
  2. Determine change in headwall position over time

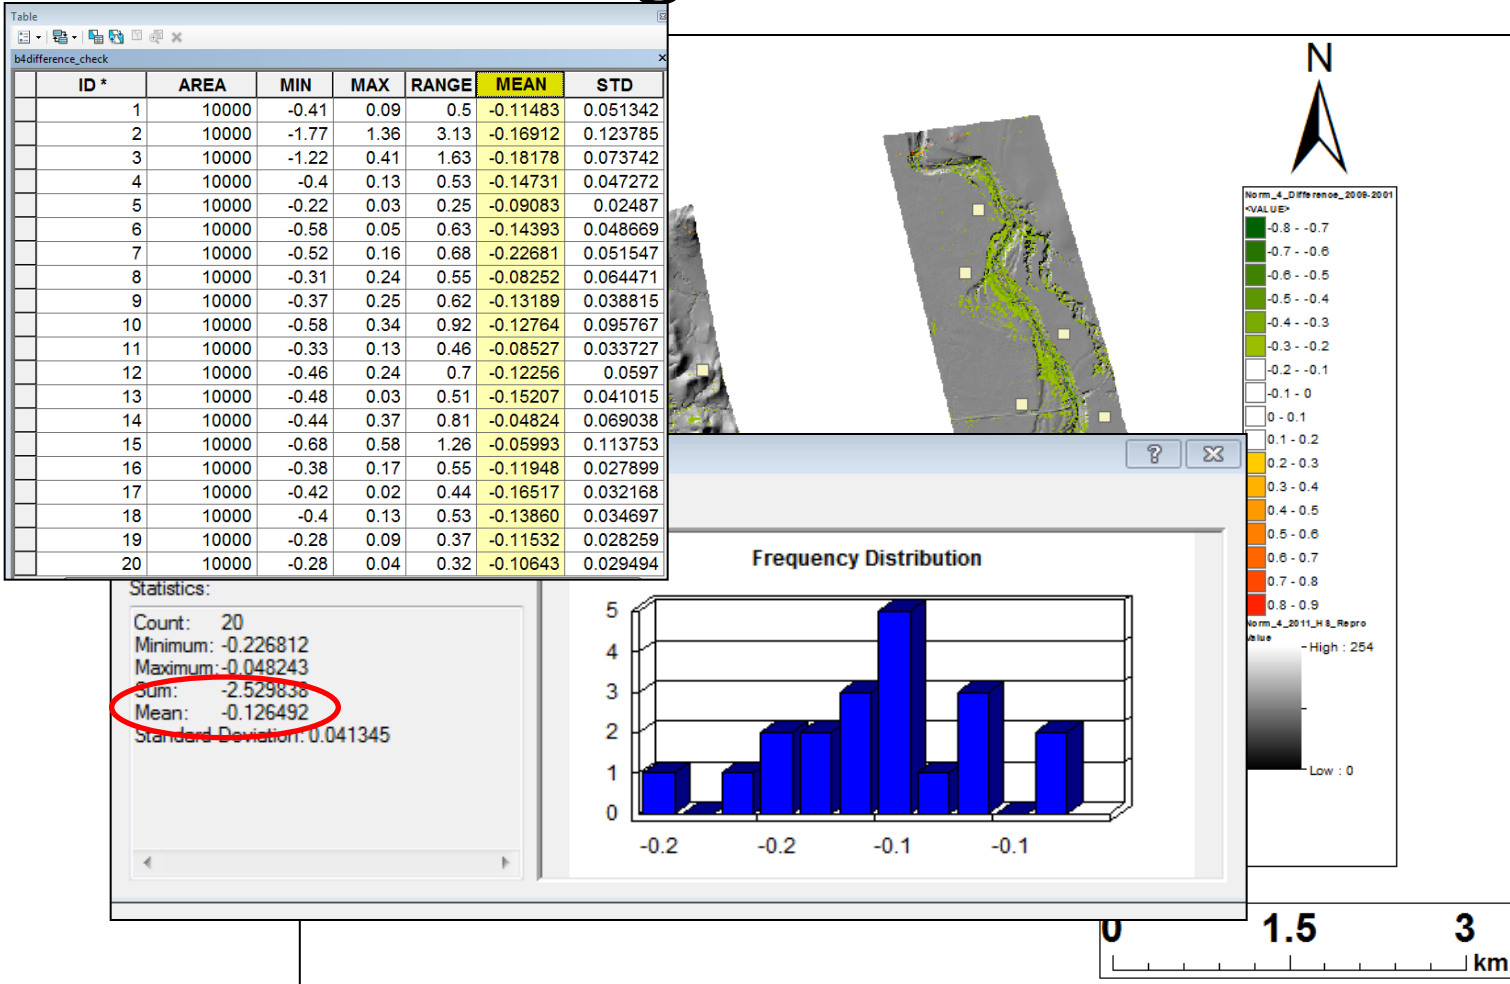
# Reduction of background noise in change detection data

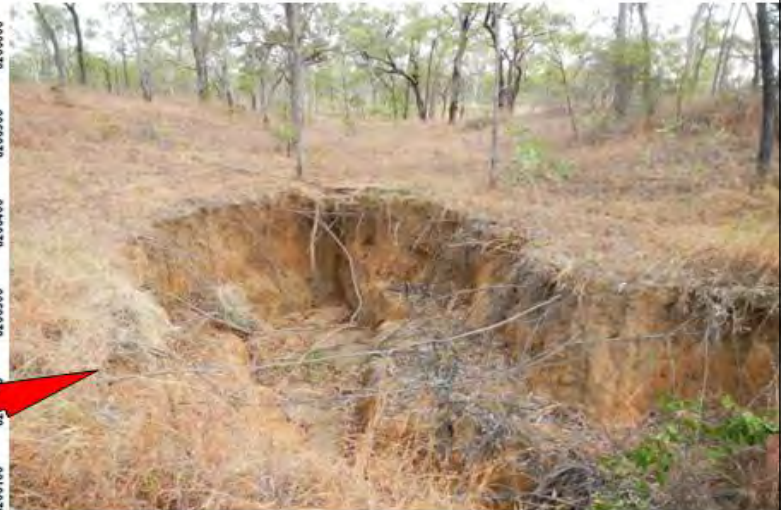
Laura River at Crocodile Gap (Norm 16)

# Erosion hotspots were ground truthed

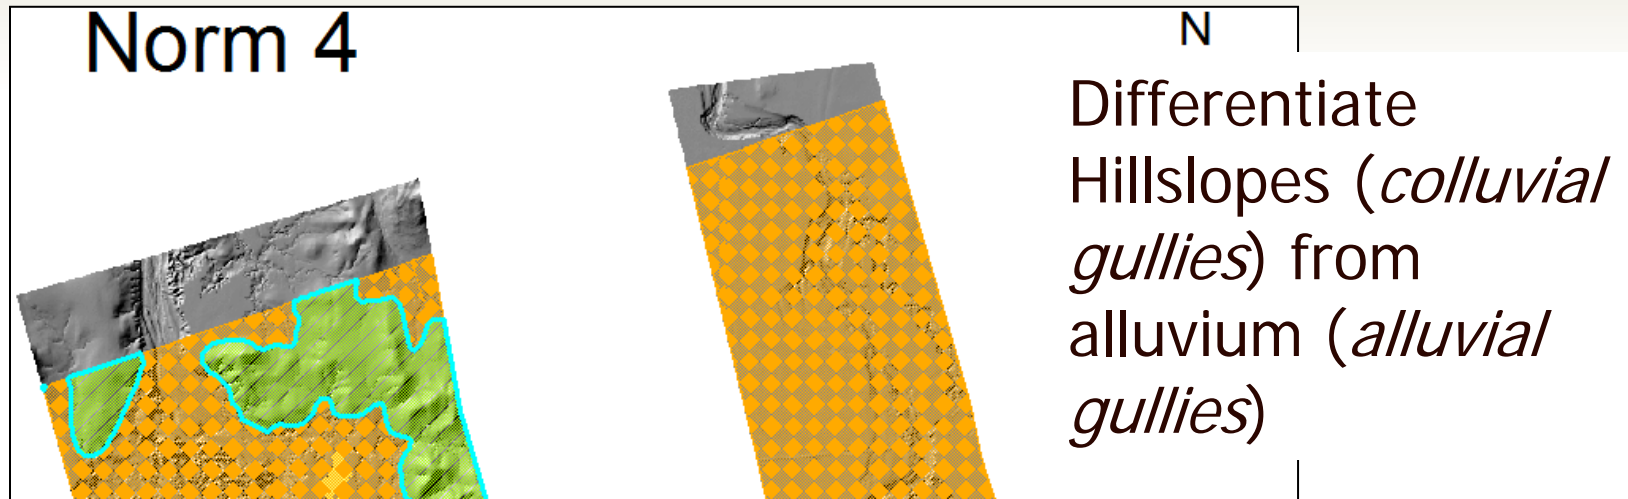
# Where in the landscape was erosion occurring?

Zone	Area (ha)	Area of Lidar gullies (ha)	Gullies as % of area
Alluvial area	1169.3	475.9	40.7
Colluvial area	392.8	37.3	9.5

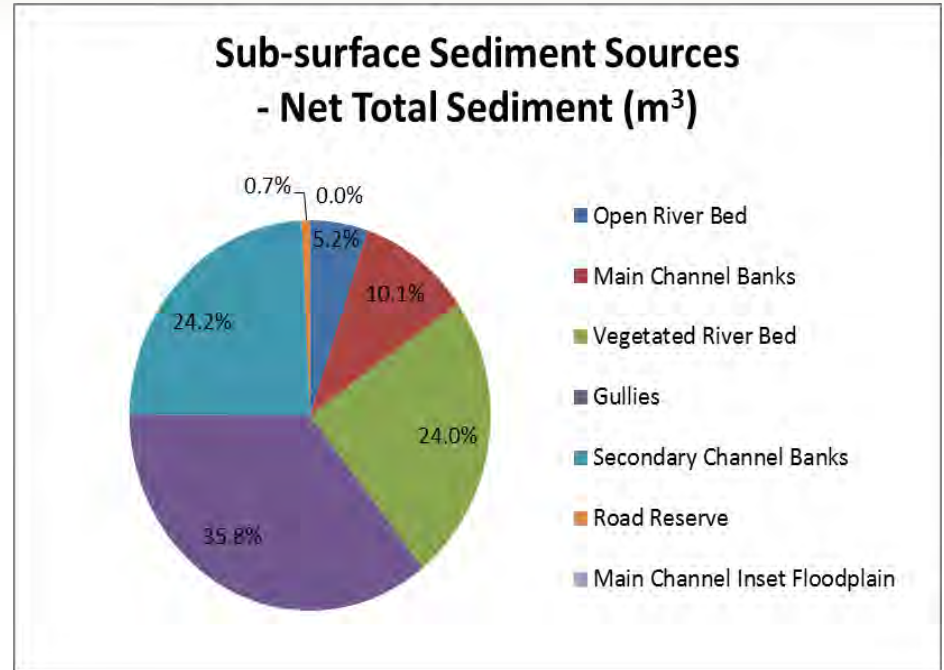
# Results

- Sub surface sediment sources were dominated by losses from gullies, 35.8%.
- Secondary channels contributed 24.2%, and vegetated riverbed 24%

Note – these data are for the LiDAR blocks alone  
- i.e. Not for the total catchment .
